Manhole Inspection Summary

Manhole # S39C__024MH

Insp Date: **11/6/08 11:40 AM**

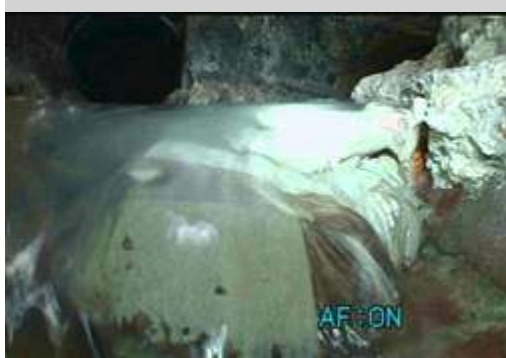
Defect 3

Condition: ☐ Sound ☐ Cracked ☐ Root Intrusion ☐ Deteriorated ☐ Leaks ☒ **Debris**

channel debris

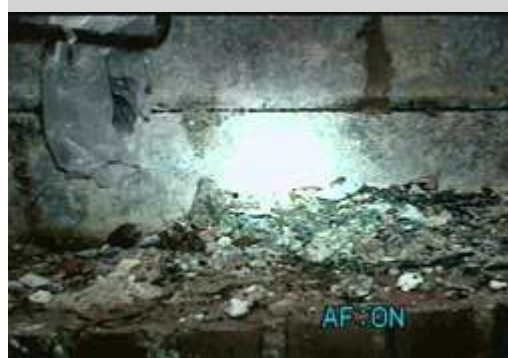
Defect 2

Condition: ☐ Sound ☐ Cracked ☐ Root Intrusion ☐ Deteriorated ☐ Leaks ☒ **Debris**

bench debris

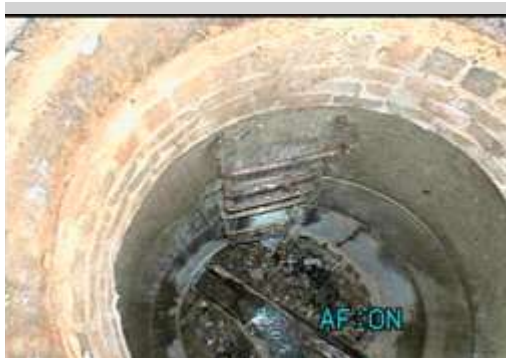
Defect 1

Infiltration: ☐ None ☒ **Joint** ☐ Cracks ☐ Mortar ☐ Roots ☐ Wall

Count: **8** Missing: **0** ☒ **Corroded**

corroded steps, barrel joint infiltration

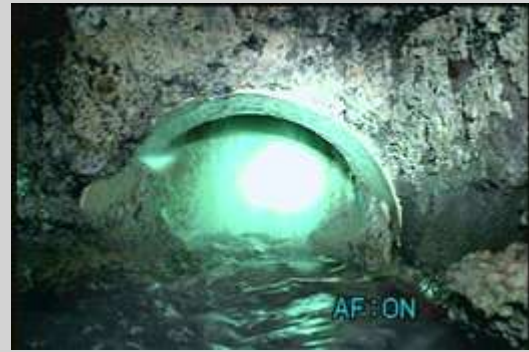
Drop In @ 7 O'Clock

Drop: **Outside Direct**

Drop Condition: **Open**
